New Paltz Central School District

Lead in Drinking Water

Remediation Compliance Program

March, 2017

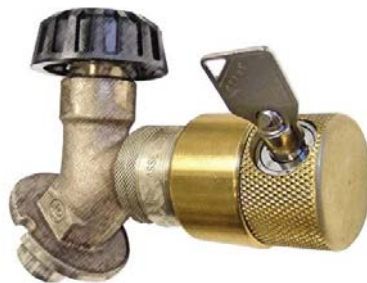
Example of hose bib lock out

- **Outside Hose Bibs/Spigots:** Hose bibs & spigots that cannot be adequately secured will be permanently taken out of service. The remaining fixtures will be locked out with a hose bib lock and only employees of the district's buildings & grounds department will have access to them. Such employees will be instructed that water from these fixtures is not to be used for drinking, filling of coolers or the watering of vegetable gardens.

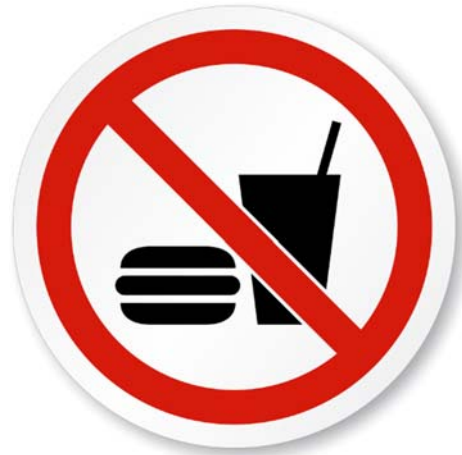
No Drinking or Eating in the Laboratory

- **Laboratory Sinks & Fixtures:** Section XI. E. of the districts' Chemical Hygiene Plan prohibits eating or drinking in the lab, prep rooms or chemical storage areas. Labs will remain locked at all times that the room is unoccupied and the teacher will monitor the sinks and instruct the students that lab sinks are not to be used for drinking. The attached signage will be posted on each wall of the lab. The teacher and custodial staff will ensure the signage remains in place.

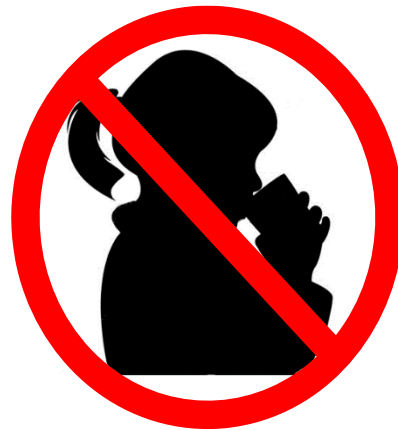
Non-Potable Water Do Not Drink
